24028 Test Report: Hail Testing of Mitrex M355-CL01F612 Modules

Report Number: 24028-PR-E-002
Report Date: 2024-06-20
Test Period: 2024-03-22 to 2024-04-22
Project ID: 24028 (CFV), P0002123 (Customer PO)
Customer: Hadi Khatibzadehazad, Mitrex
41 Racine Rd, Toronto, ON, M9W 2Z4, Canada

Project Summary

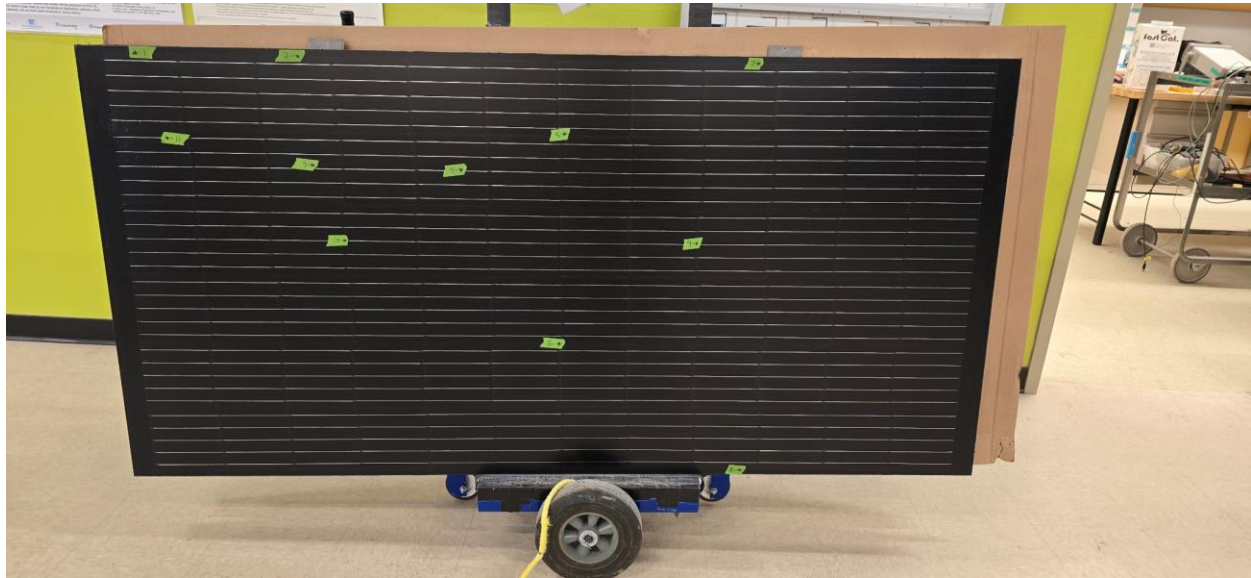
24028-003 (55mm)

Shot	Impact Location	Result	Ice Ball Weight (g)	Ice Ball Velocity (m/s)
1	Module Corner	Pass	78.17	33.97
2	Module Edge	Pass	78.55	33.69
3	Interconnects	Pass	76.24	33.69
4	Interconnects	Pass	77.59	34.25
5	Circuit Edge	Pass	77.94	33.97
6	Circuit Edge	Pass	76.95	33.78
7	Mounting Points	Pass	77.46	33.78
8	Mounting Points	Pass	77.97	34.15
9	Module Center	Pass	77.34	33.51
10	Module Center	Pass	77.26	33.69
11	Junction box	Pass	77.16	33.78
Overall Result		Pass

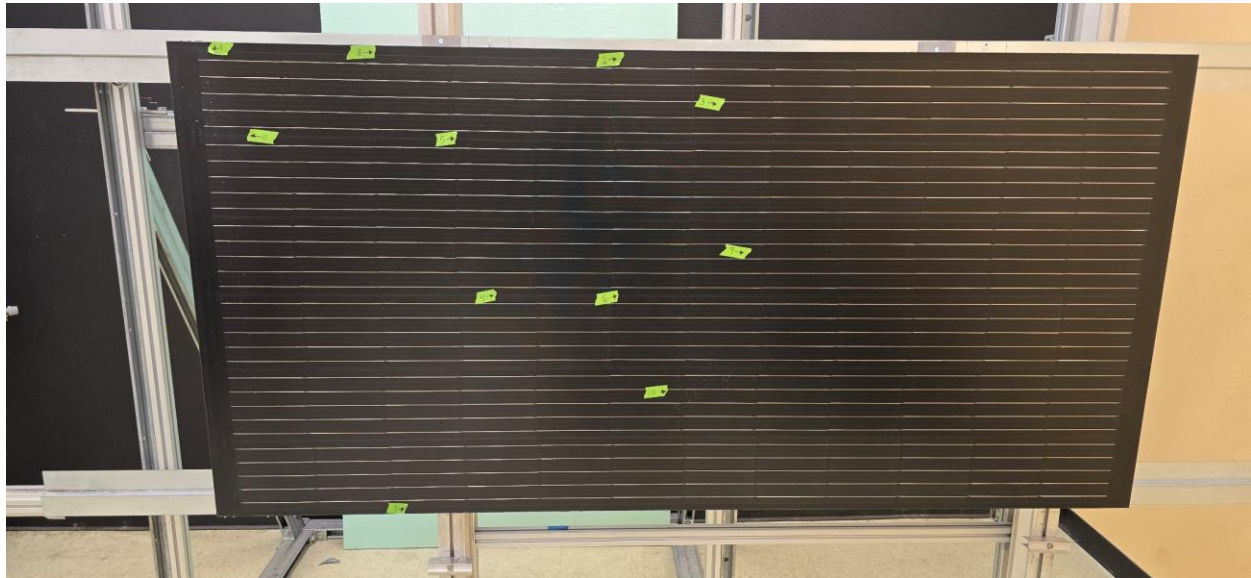
24028-002 (65mm)

Shot	Impact Location	Result	Ice Ball Weight (g)	Ice Ball Velocity (m/s)
1	Module Corner	Pass	126.24	36.02
2	Module Edge	Pass	126.74	36.44
3	Interconnects	Pass	125.56	35.92
4	Interconnects	Pass	126.51	35.71
5	Circuit Edge	Pass	128.51	36.87
6	Circuit Edge	Pass	130.56	37.65
7	Mounting Points	Pass	128.14	37.09
8	Mounting Points	Pass	129.77	36.98
9	Module Center	Pass	126.37	36.34
10	Module Center	Pass	128.85	35.82
11	Junction box	Pass	128.55	36.87
Overall Result		Pass

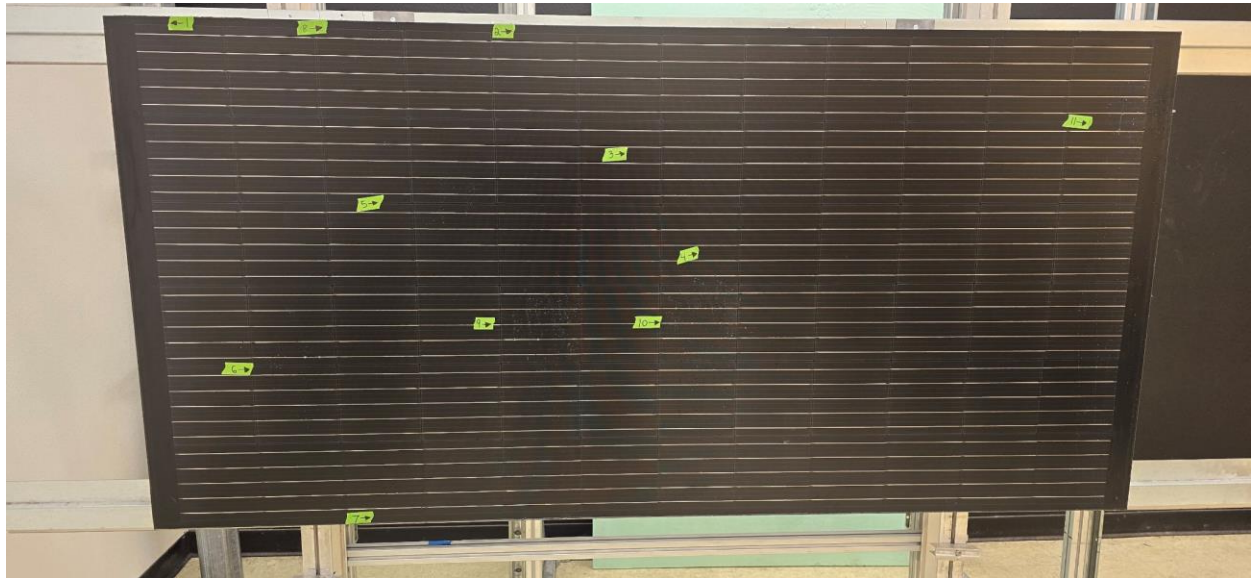
24028-001 (75mm)

Shot	Impact Location	Result	Ice Ball Weight (g)	Ice Ball Velocity (m/s)
1	Module Corner	Pass	198.74	38.94
2	Module Edge	Pass	194.38	38.70
3	Interconnects	Pass	195.29	38.94
4	Interconnects	Pass	193.76	39.06
5	Circuit Edge	Pass	196.88	39.94
6	Circuit Edge	Pass	194.23	39.06
7	Mounting Points	Pass	194.07	39.56
8	Mounting Points	Pass	193.22	38.46
9	Module Center	Pass	195.80	39.94
10	Module Center	Pass	194.17	39.06
11	Junction box	Pass	197.27	40.19
Overall Result		Pass
