MITREX TEST REPORT

CAN/ULC S134, STANDARD METHOD OF FIRE TESTS OF EXTERIOR WALL ASSEMBLIES
CONTAINING MITREX CLADDING SYSTEM

G104760082SAT-002 R0

TEST REPORT FOR MITREX

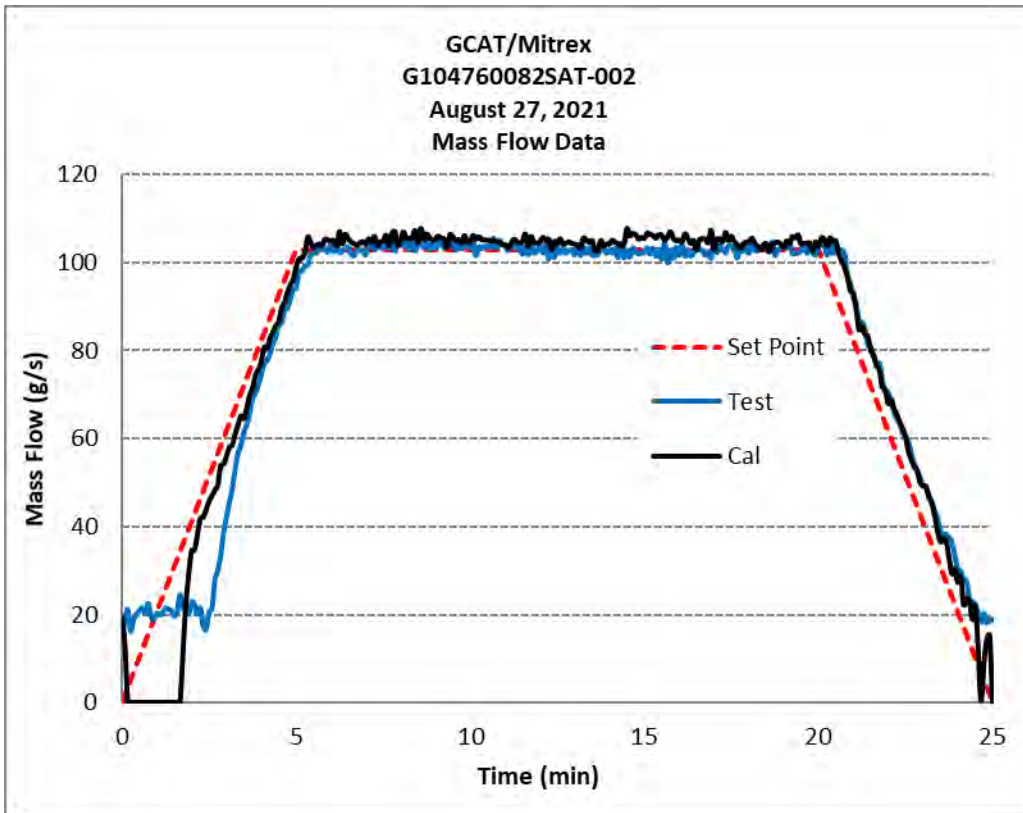
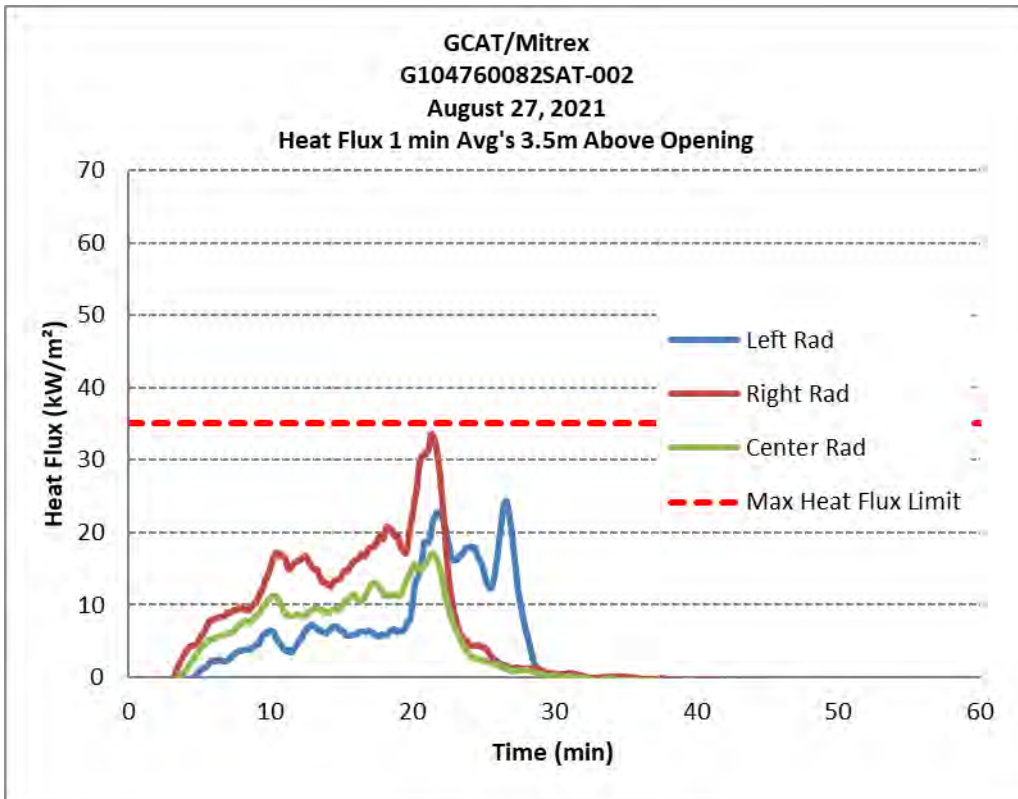
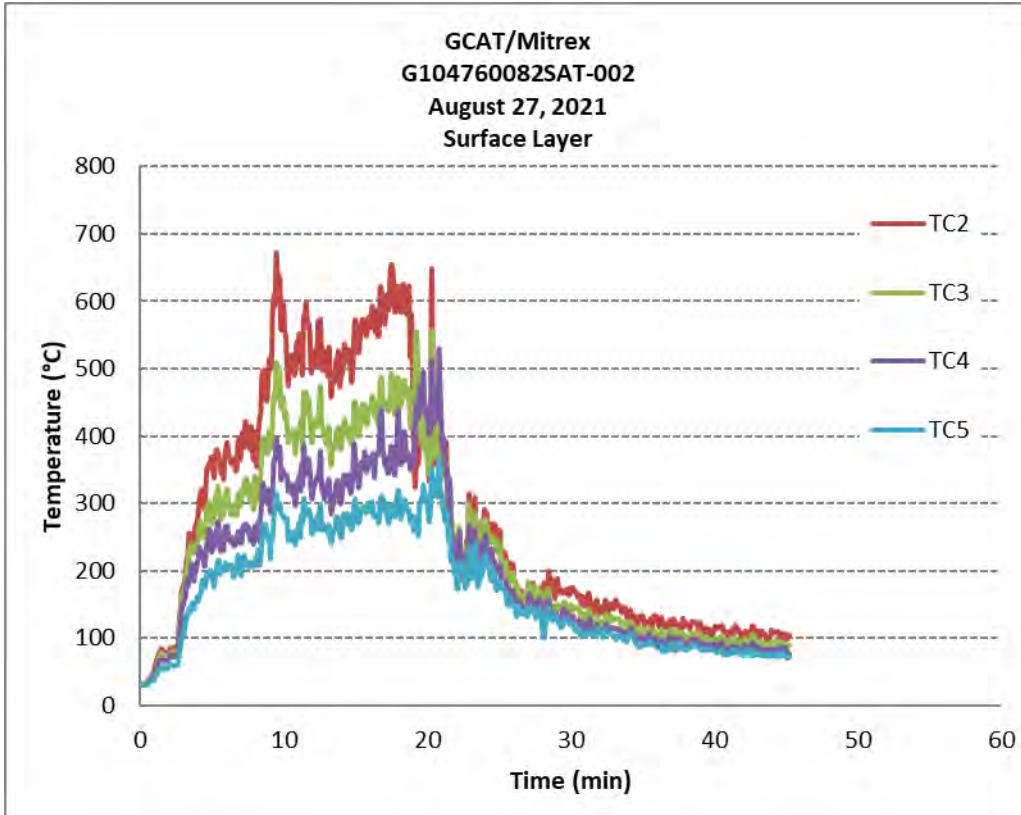
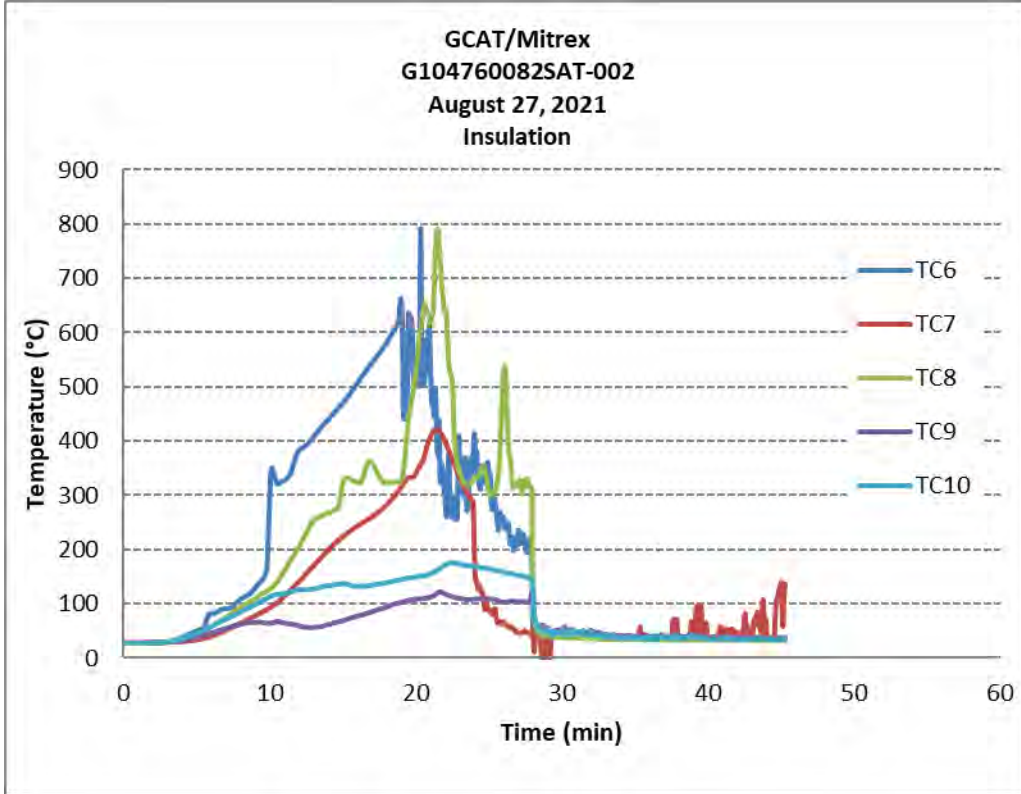
GRAPHS

The output of the transducers and thermocouples were monitored by a National Instruments CDAQ-9188 Data Acquisition Unit. The data acquisition system was programmed to scan and save data every 5 seconds. Following the test, the files were imported into MS Excel for graphical display. The graphical display data can be found in Section 13.

Three water cooled heat flow transducers (0-100 kW/m²) were installed through the test specimen and the front wall of the test chamber 3.5 m above the top of the window opening; one within 0.2 m ± 0.05 m horizontally of the center line of the opening and one on each side and within 0.5 ± 0.1 m horizontally from the first. The transducers were installed so that their sensing faces were flush with the outer face of the test specimen. Two (2) layers of 24 GA (0.51 mm), Type K bare beaded thermocouples were used to monitor temperature of the specimen and were located on the vertical center line and above the opening at 1.5 ± 0.05 m, 2.5 ± 0.05 m, 3.5 ± 0.05 m, 4.5 ± 0.05 m, 5.5 ± 0.05 m. At each of these levels, one thermocouple was installed on the interface between the test structure and insulation behind the panels and at the outer layer of the specimen.
