# MITREX INC. FIRE TEST REPORT

NFPA 285 TESTING ON EXTERIOR NON-LOAD-BEARING WALL ASSEMBLY CONTAINING MITREX INC. SOLAR PANELS (PRODUCT NAME – MITREX A)

N8164.01-121-24

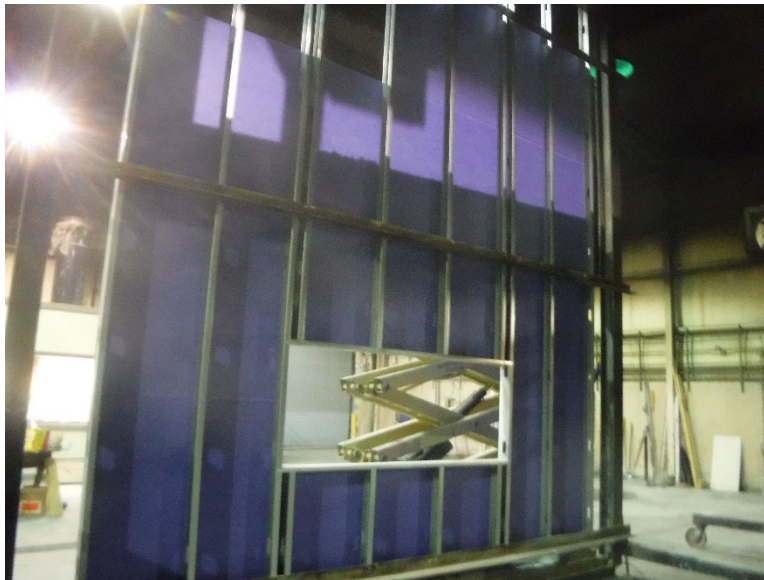
**Photo No. 1**  
**Core Wall Construction**

The core wall consisted of 18 ft. long, 3-5/8 in. deep, 20-gauge galvanized steel studs fastened to 14 ft. length, 3-5/8 in. deep, 20-gauge galvanized steel track every 24 inches on center. The studs were connected to the track with one #6 x 1/2 in. long self-drilling, pan head fastener per stud flange. Two additional 18 ft. long, 3-5/8 in. deep, 20-gauge studs were used as king studs for the window opening jambs. ROCKWOOL™ Cavityrock® pieces with a nominal density of 4.0 lb./cu. ft. were installed per the manufacturer's installation instructions to fit into each stud cavity placed at the second story floor line. The safing length dimensions were no less than the apparatus floor slab thickness of 8 in.

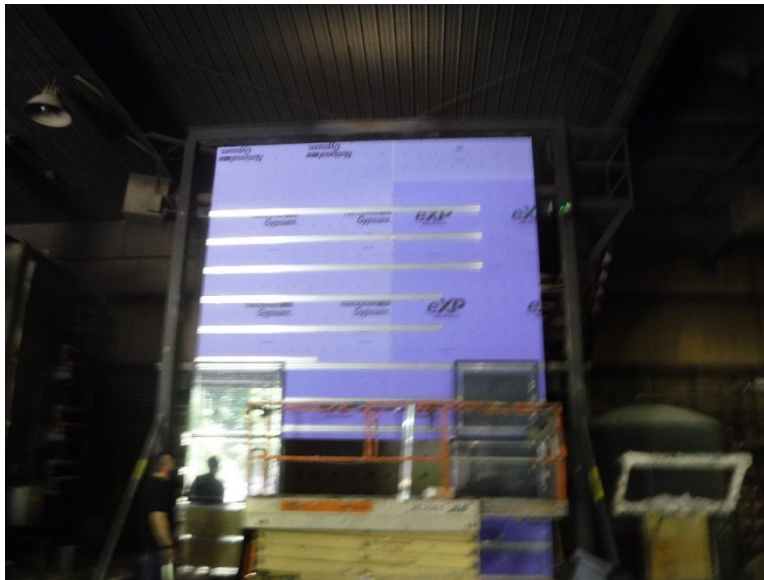
**Photo No. 3**  
**Installation of the Horizontal Rails**

The exterior cladding assembly was installed using 3" in high x 1" deep extruded rails (Aluminum Alloy 6063 T6) attached horizontally over the full width of the wall assembly. For vertical spacing of the horizontal rail system, reference the attached drawing specify the rail locations. The horizontal rail system was fastened to the exterior sheathing using self-tapping fasteners, 2 numbers of #10-16 x 2" Hex - Unslotted Drive Indented Hex Washer Head Zinc Finish #3 Point Steel Self-Drilling Screw positioned on the vertical channels of the base-wall (i.e. 24 inches on center), supplied by the installers of the panel assembly. Following the installation of the exterior insulation, the exterior cladding was installed. The exterior cladding consisted of proprietary solar panels (MITREX A), manufactured using two layers of tempered glass, with solar cells in between the two sheets of glass, installed in 40mm deep and 35mm wide aluminium frame along the vertical and horizontal edges using silicone sealant. The solar panels consisted of an overall thickness of 1/2 in. throughout the face and edges of the panel, with a 1 in. air gap on the back of the panel. 3" high x 1" deep extruded rails were installed along the unexposed face of the solar panel aluminium framing, using 2 numbers of #10x3/4" Self-drill hex head steel Tek screws along the vertical solar panel framing members and maximum 12 in. distance on center along the horizontal solar panel framing members, to allow the panels to be installed on the horizontal rail system installed on the exterior sheathing of the wall assembly. The spacing of the horizontal rails installed on the solar panels directly corresponds with the spacing of the rail system on the exterior sheathing of the wall assembly and is prescriptive to the specific location of each solar panel. 1/4" wide horizontal and vertical joints between the solar panels were capped with Dowsil™ Contractors Weatherproofing Sealant. All factory componentry of the solar panels was left on the solar panel system and was not connected to other energized electrical componentry as would be found in the field at the conclusion of the panel system installation. All exterior assembly components beyond the exterior gypsum sheathing were installed by Mitrex personnel. After completing the assembly of the exterior solar wall panel system, the outside perimeter of the specimen was flashed with 0.019 aluminum trim coil that was bent 90 degrees and taped to both the exterior panel surface and the outside webbing of the studs and top and bottom track with Nashua foil tape.

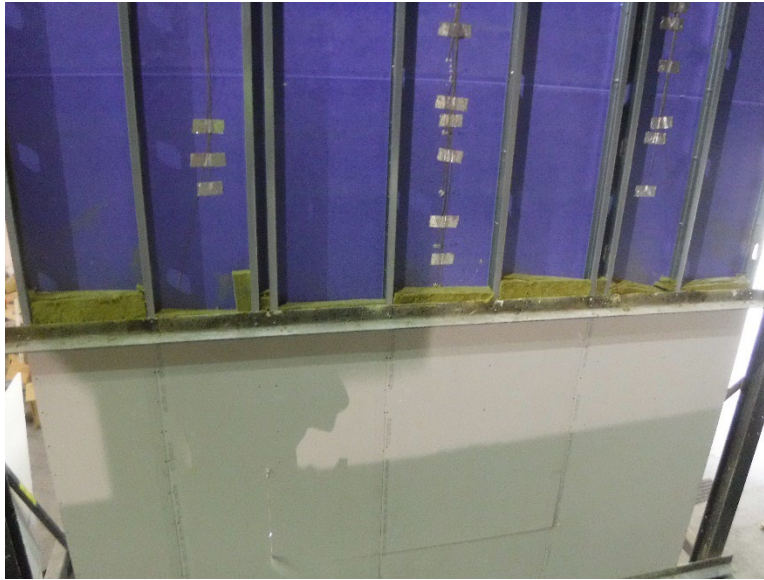
**Photo No. 5**  
**Floor Safing Installation**

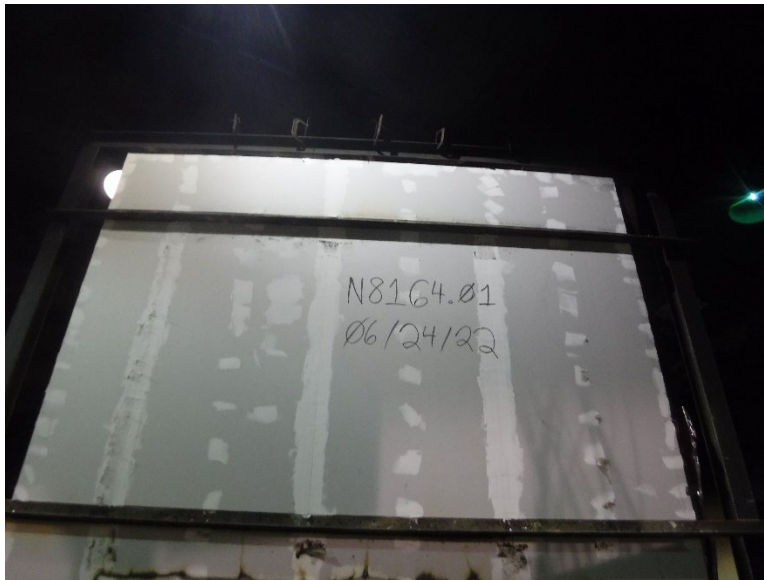
**Photo No. 19**  
**Second Story Interior Gypsum (Post-Test)**
