21080 Test Report:

IEC TS 63209-1 Sequence 3 Sequential Testing Including UV on Module Back-side on M390-D1FB Modules Produced by Mitrex

Report Number: 21080C-PR-E-001
Report Date: 2022-11-22
Test Period: 2022-02-07 to 2022-11-18
Project ID: 21080 (CFV), 000477 (Customer PO)
Customer: Hadi Khatibzadehazad / Mitrex
41 Racine Rd
Etobicoke, Ontario M9W 2Z4
Canada

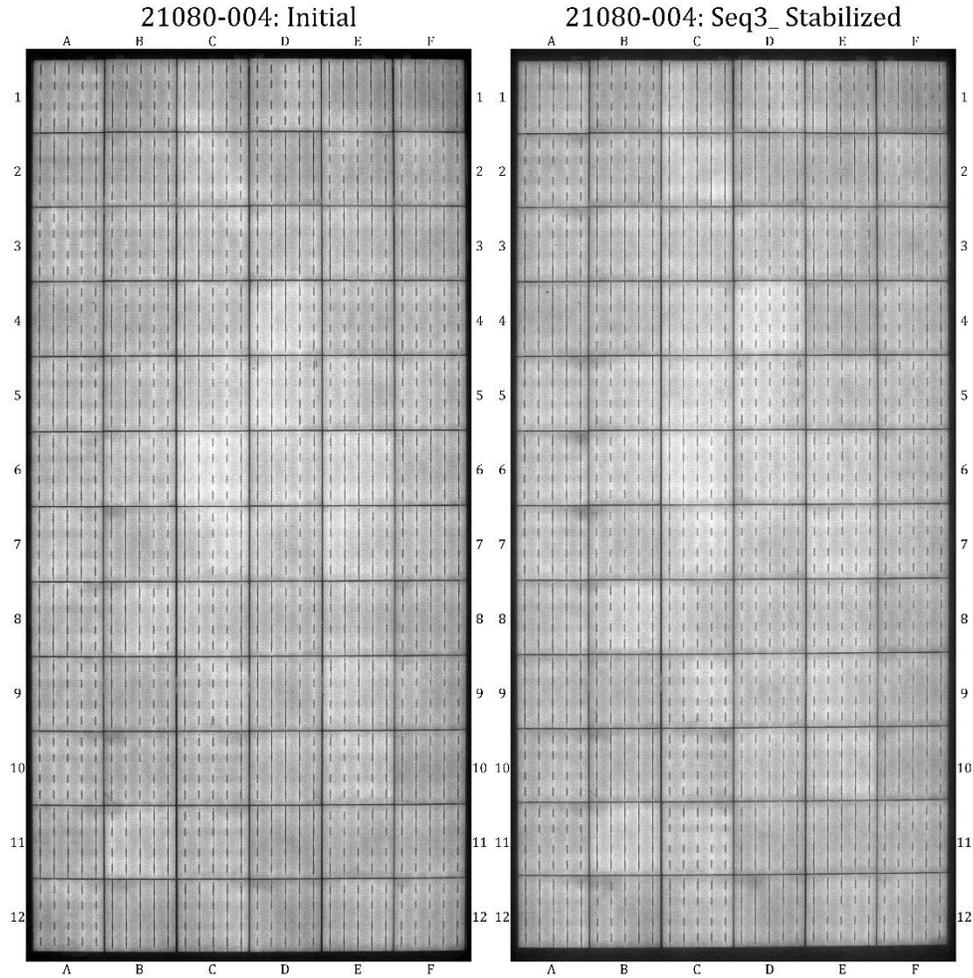
Electroluminescence Imaging

Module 21080-004 (Images taken at $0.1 \times I_{sc}$ are provided separately in digital format)
