21080 Test Report:

63209+ Sequence 4 Damp Heat Testing on M390-D1FB Modules Produced by Mitrex

Report Number: 21080D-PR-E-001
Report Date: 2022-08-08
Test Period: 2022-02-07 to 2022-07-28
Project ID: 21080 (CFV), 000477 (Customer PO)
Customer: Hadi Khatibzadehazad / Mitrex
41 Racine Rd
Etobicoke, Ontario M9W 2Z4
Canada

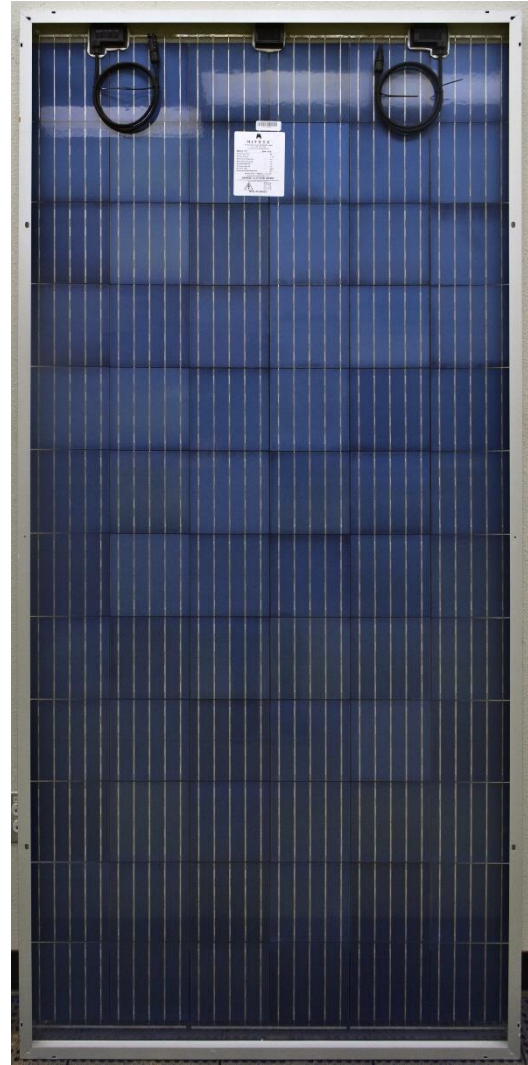
Module Type: M390-D1FB

Sample Type Images
