## 21080 Test Report:

### IEC TS 63209-1 Sequence 5 Potential Induced Degradation Testing on M390-D1FB Modules Produced by Mitrex

**Report Number:** 21080E-PR-E-001  
**Report Date:** 2022-06-28  
**Test Period:** 2022-02-07 to 2022-06-24  
**Project ID:** 21060 (CFV), 000477 (Customer PO)  
**Customer:** Hadi Khatibzadehazad/ Mitrex  
41 Racine Rd.  
Etobicoke, Ontario M9W 2Z4  
Canada

CFV Labs conducted extended reliability testing on two **M390-D1FB** modules produced by **Mitrex** per IEC TS 63209-1 Sequence 5.

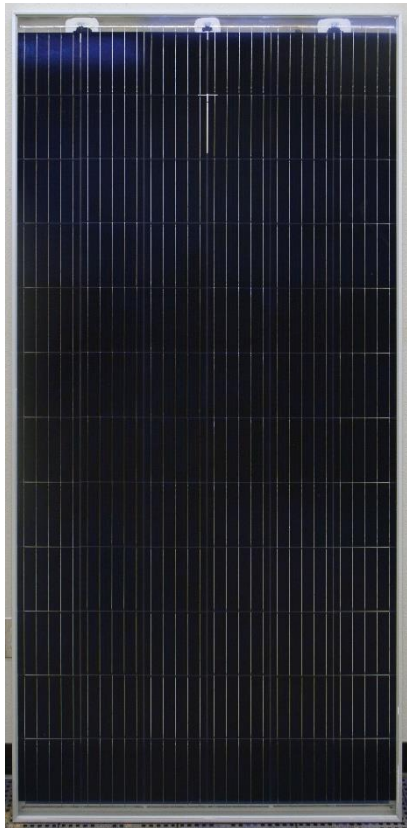
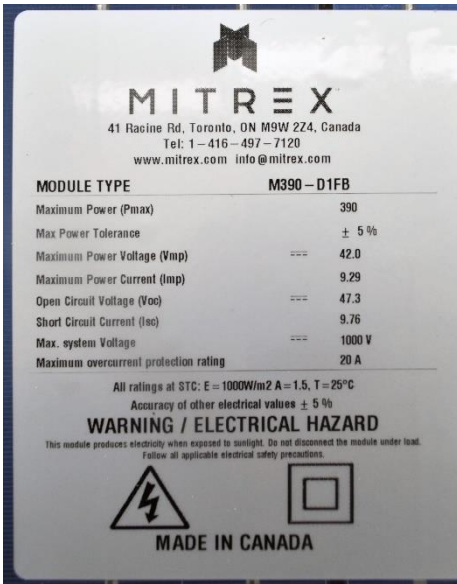
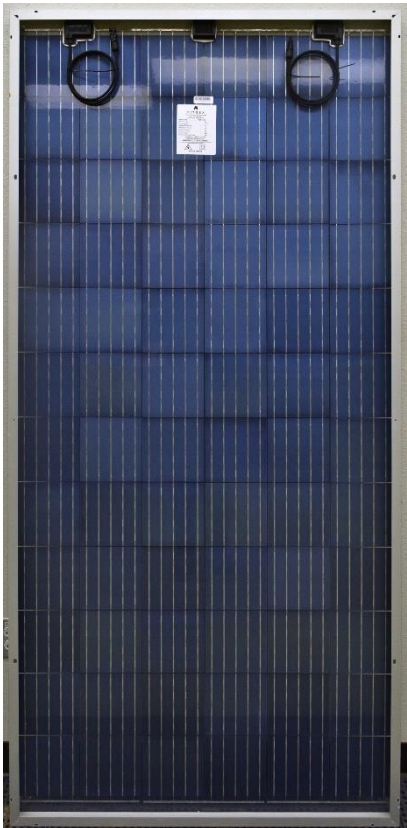
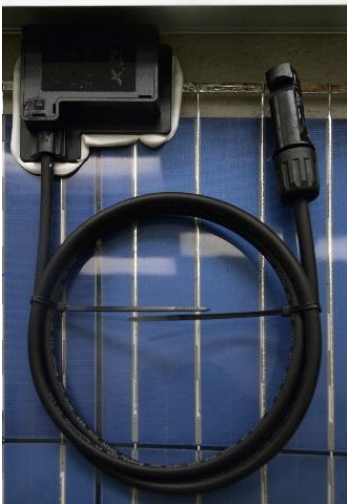
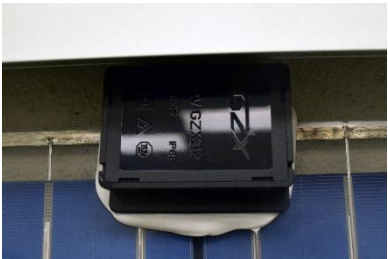
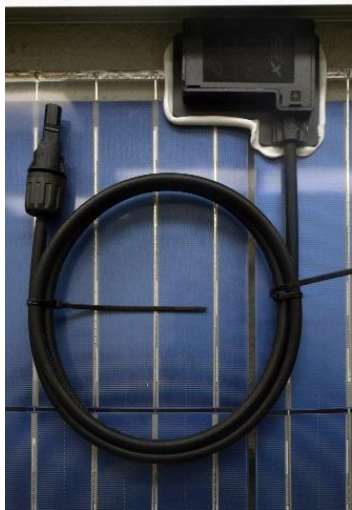
Sample Type Images

Module (M390-D1FB)

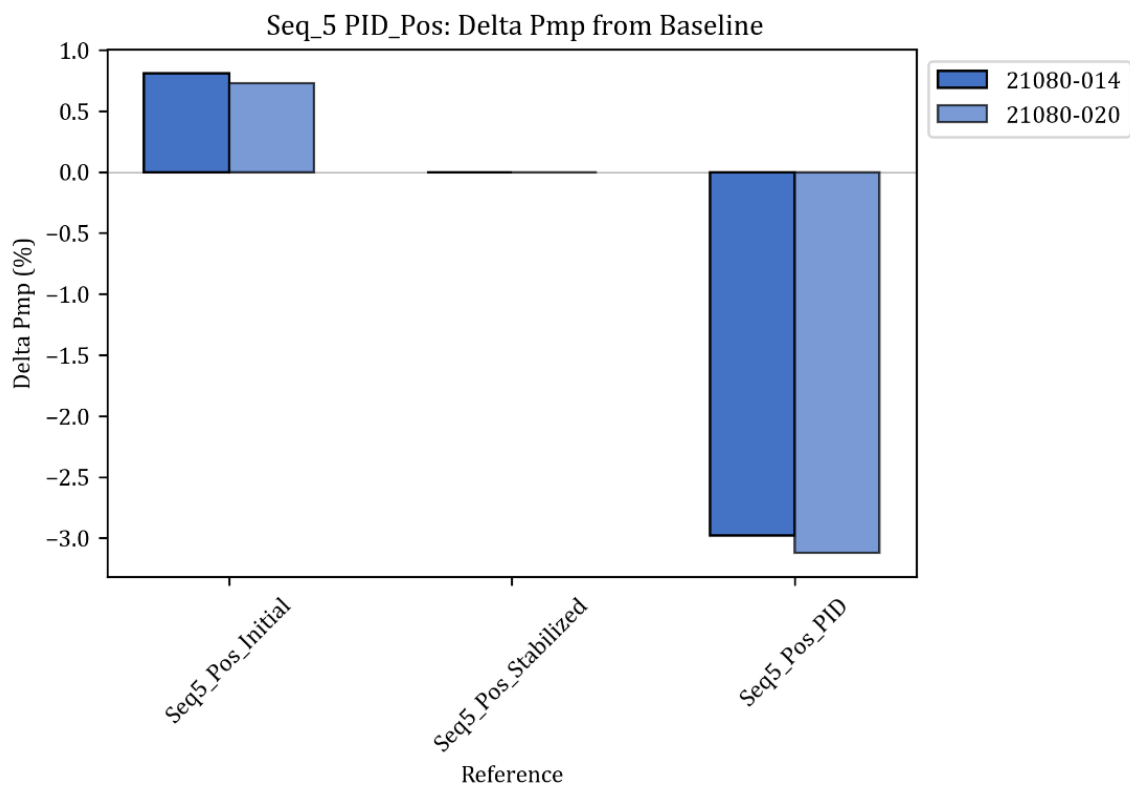
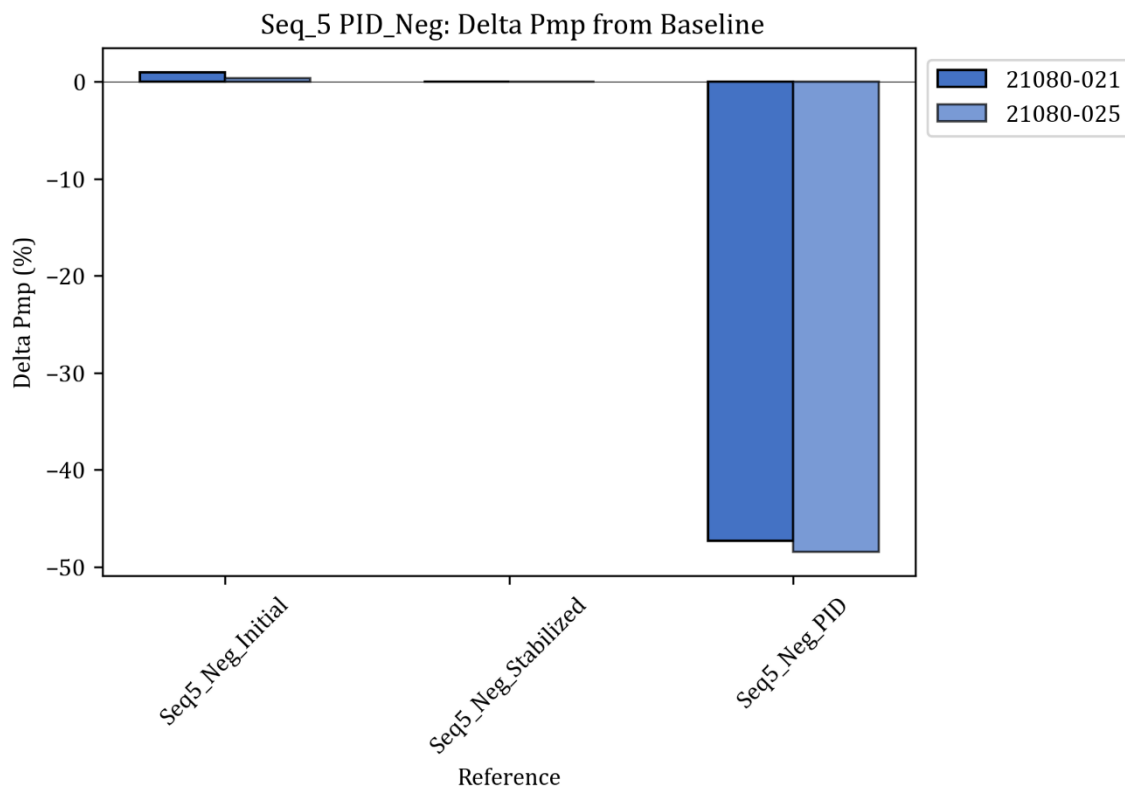
The plots below show the Performance at STC measurement values as a percentage change from the Stabilized values.

The average change in STC Pmp [W] from initial to the final post-stress testing was measured to be -3.05 % and -47.91 % for the positive and negative polarity test respectively. The modules passed all safety tests and all visual inspections.

## Performance at STC – Change from Stabilized
