21080 Test Report:

IEC TS 63209-1 Sequence 1 Thermal Fatigue Testing on M390-D1FB Modules Produced by Mitrex

Report Number: 21080A-PR-E-001
Report Date: 2022-08-08
Test Period: 2022-02-07 to 2022-07-27
Project ID: 21080 (CFV), 000477 (Customer PO)
Customer: Hadi Khatibzadehazad / Mitrex
41 Racine Rd
Etobicoke, Ontario M9W 2Z4
Canada

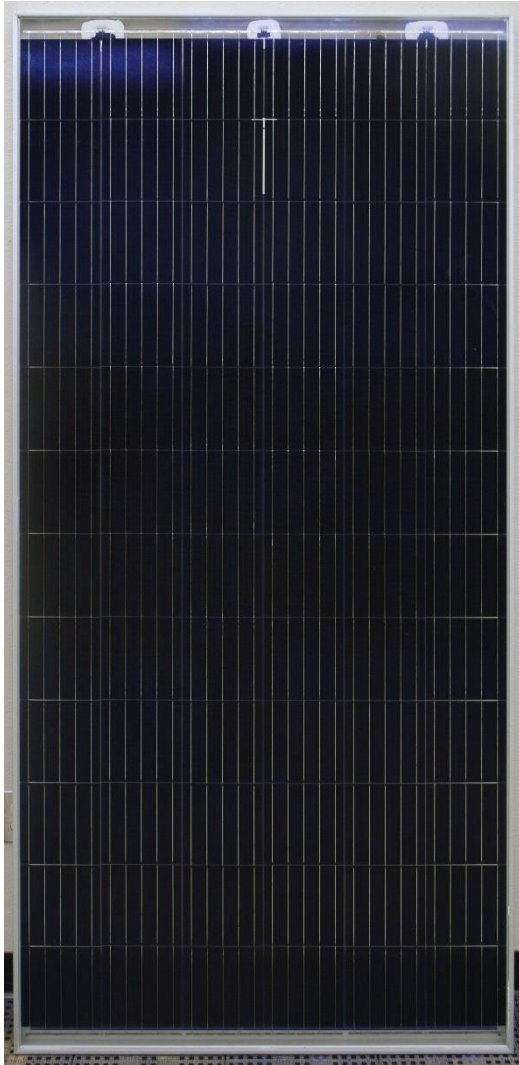
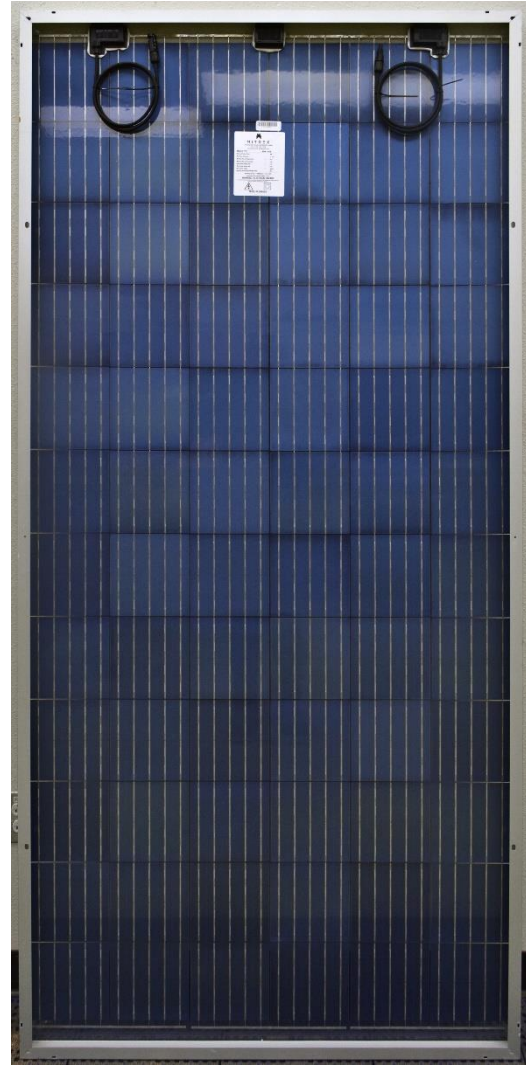
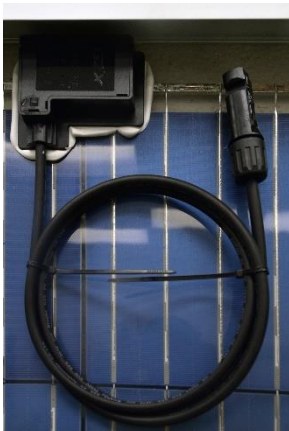
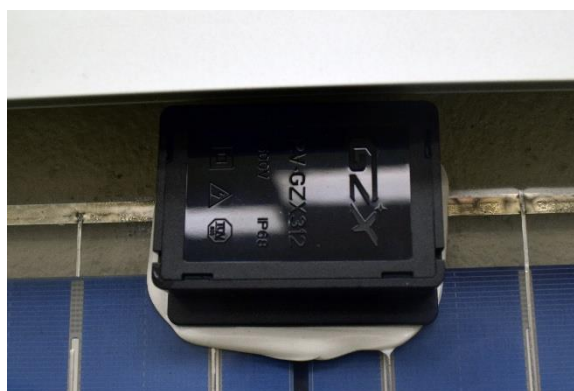
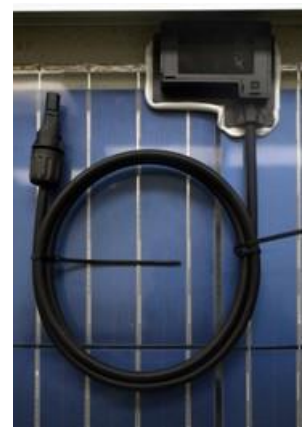
Module Type: M390-D1FB

Sample Type Images

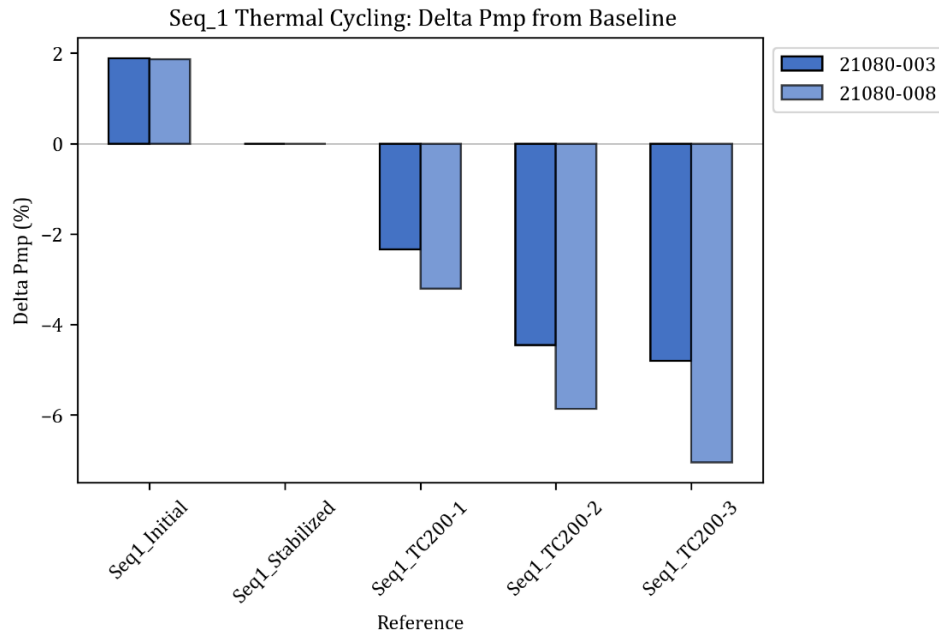
The plots below show the Performance at STC measurement results as a change from Baseline (Stabilized).

The average change in STC Pmp [W] from initial to the final post-stress testing was measured to be -5.93 %. The modules passed all safety tests and all initial, interim, and final visual inspections.
