## 21080 Test Report: IEC TS 63209-1 Sequence 2 Mechanical Stress Testing on M390-D1FB Modules Produced by Mitrex

**Report Number:** 21080B-PR-E-001  
**Report Date:** 2022-08-08  
**Test Period:** 2022-02-07 to 2022-07-27  
**Project ID:** 21080 (CFV), 000477 (Customer PO)  
**Customer:** Hadi Khatibzadehazad / Mitrex  
41 Racine Rd  
Etobicoke, Ontario M9W 2Z4  
Canada

CFV Labs conducted extended reliability testing on two **M390-D1FB** modules produced by **Mitrex** per IEC TS 63209-1 Sequence 2 Mechanical Stress.

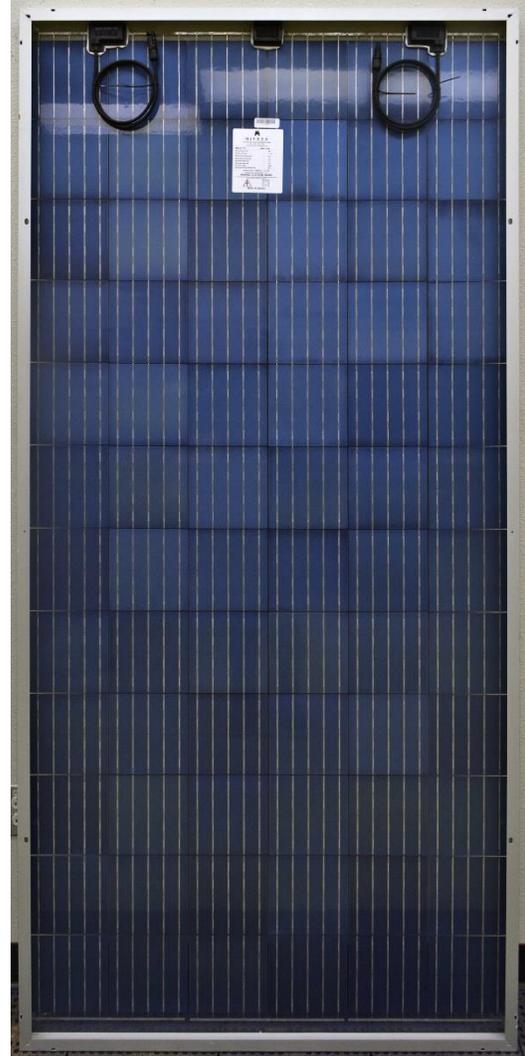
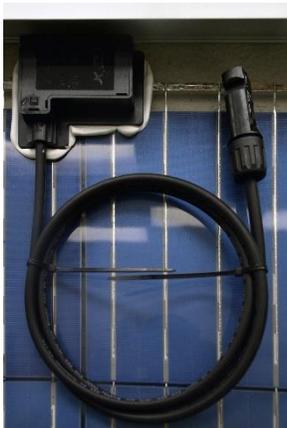
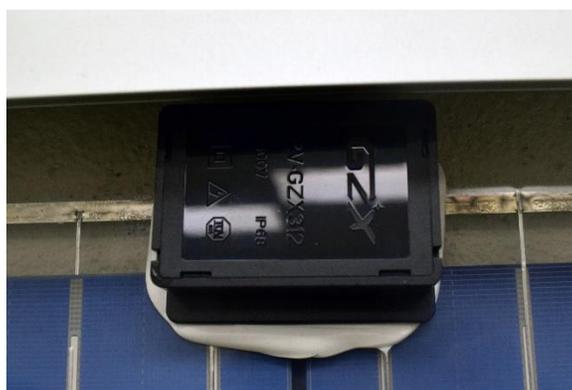
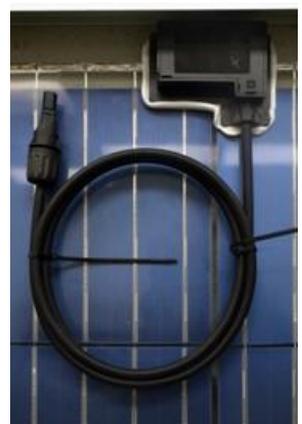
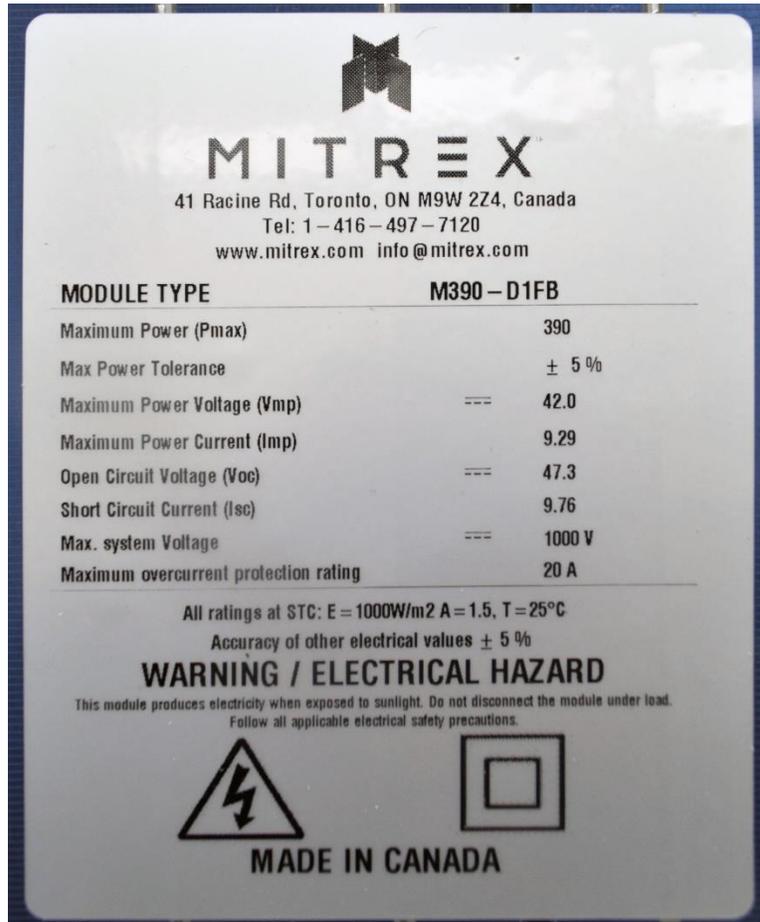
Module Type: M390-D1FB

## Sample Type Images

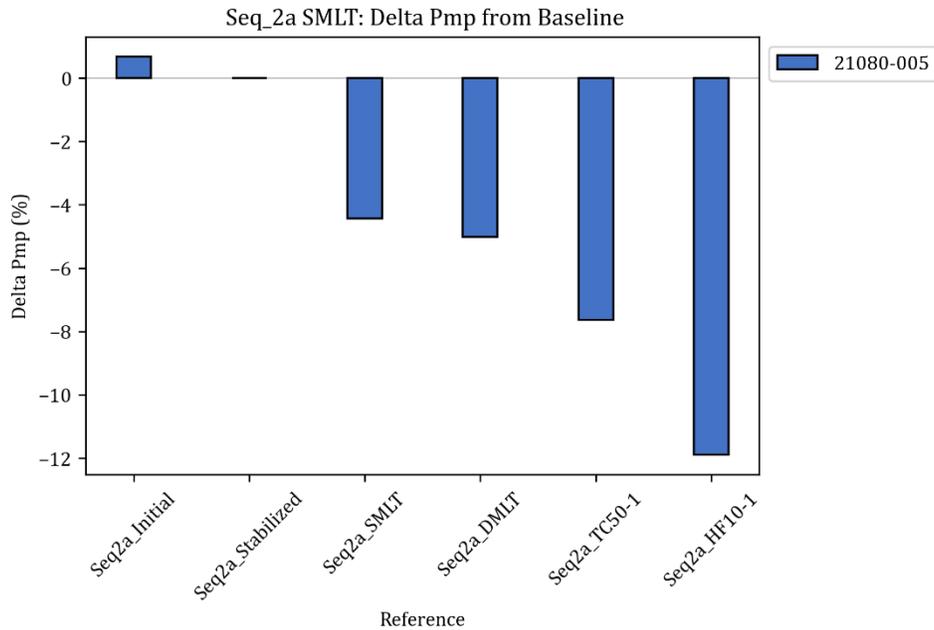
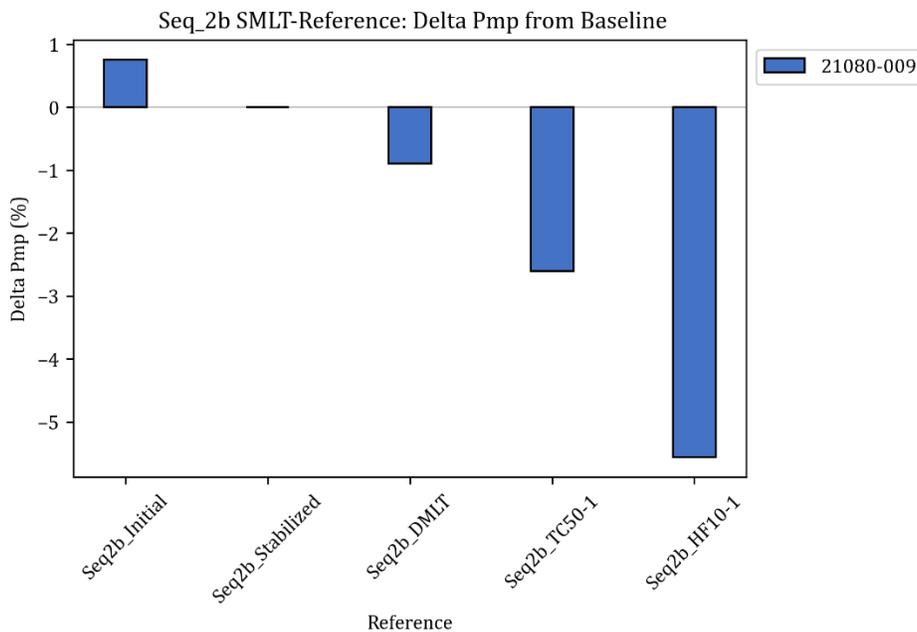
The plots below show the Performance at STC measurement results as a change from Baseline (Stabilized).

The change in STC Pmp [W] from initial to the final post-stress testing for the standard and reference modules respectively was measured to be *-11.89 % and -5.56 %*. The modules passed all safety tests and all initial, interim, and final visual inspections.

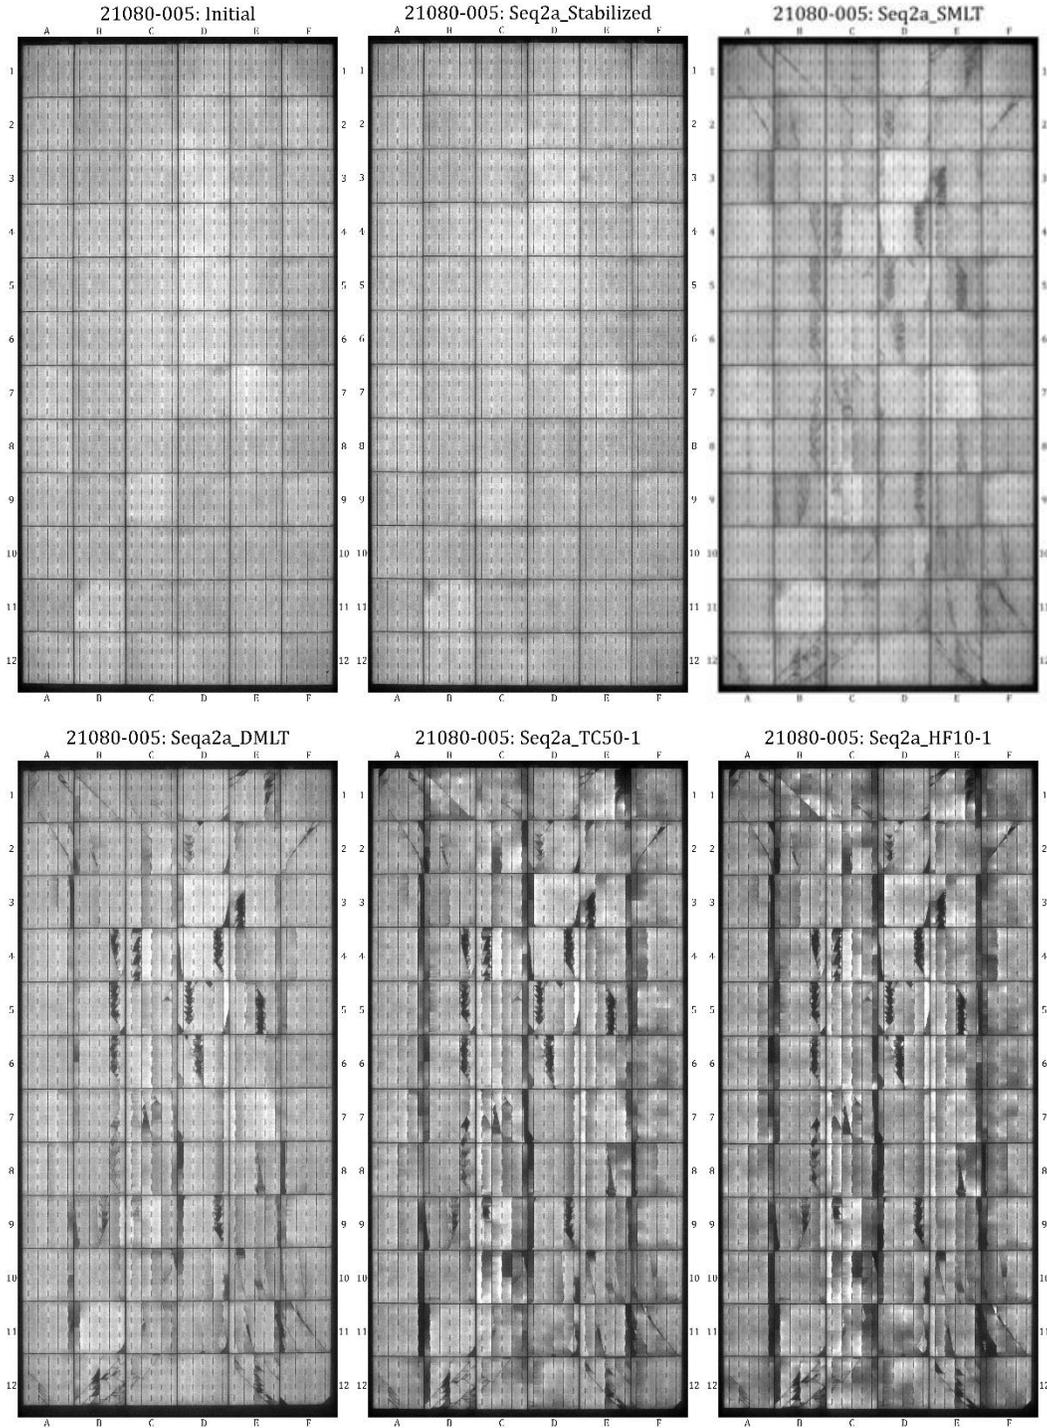
Module 21080-005 (Images taken at  $0.1 \times I_{sc}$  are provided separately in digital format)

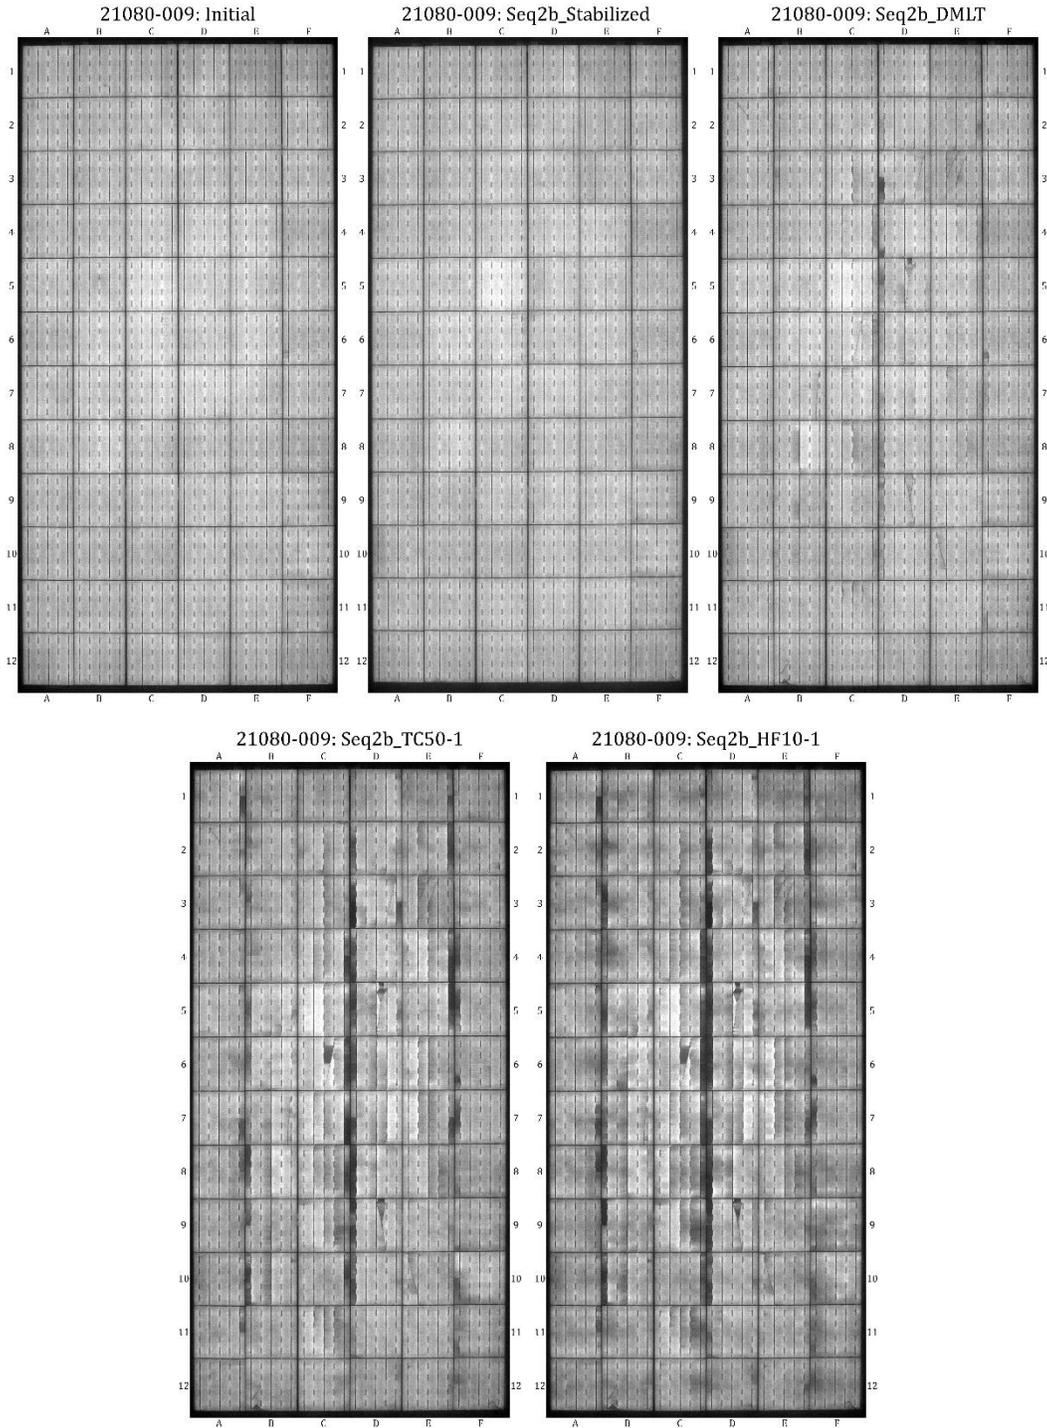
Module 21080-009 (Images taken at 0.1 x Isc are provided separately in digital format)

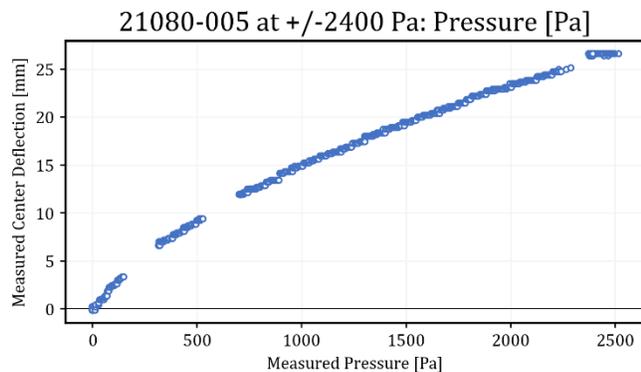
#### Pressure vs Deflection Plot and Data

Pass/Fail also determined by follow-up MQT 01 Visual Inspection and MQT 15 Wet Leakage Current. Module was installed on the two support rails of the mechanical load tester running parallel to the module short-side. It was secured using industry standard 100 mm top clamps at the long-side quarter points.

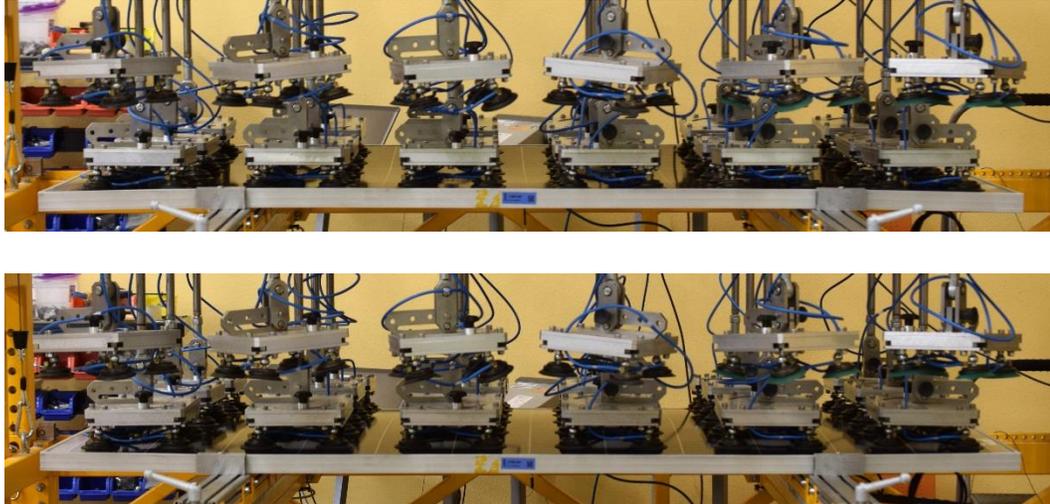
## Module Deflection Images at Maximum Downward (Top) and Upward Loads (Bottom)
