24028 Test Report: Hail Testing of Mitrex M355-CL01F612 Modules

Report Number: 24028-PR-E-002
Report Date: 2024-06-20
Test Period: 2024-03-22 to 2024-04-22
Project ID: 24028 (CFV), P0002123 (Customer PO)
Customer: Hadi Khatibzadehazad, Mitrex
41 Racine Rd, Toronto, ON, M9W 2Z4, Canada

Project Summary

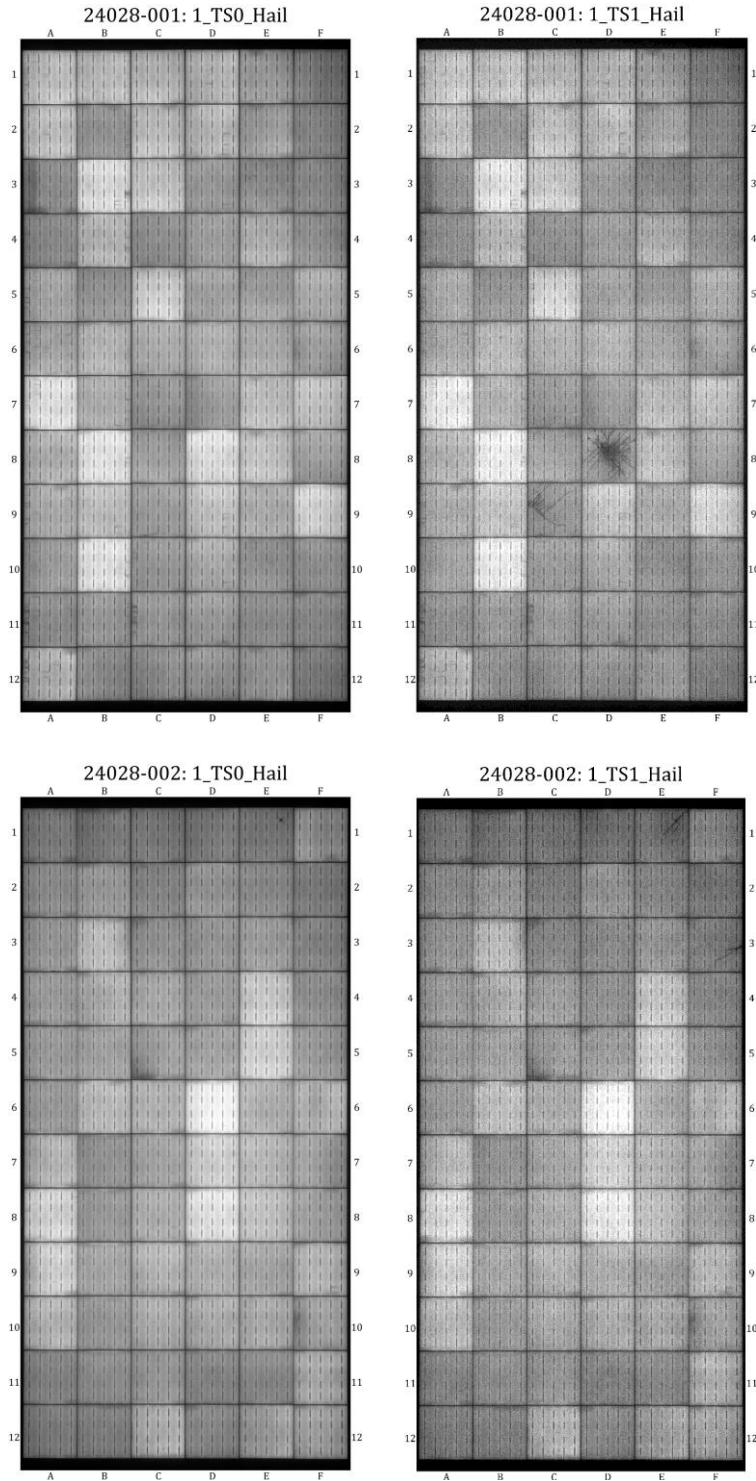
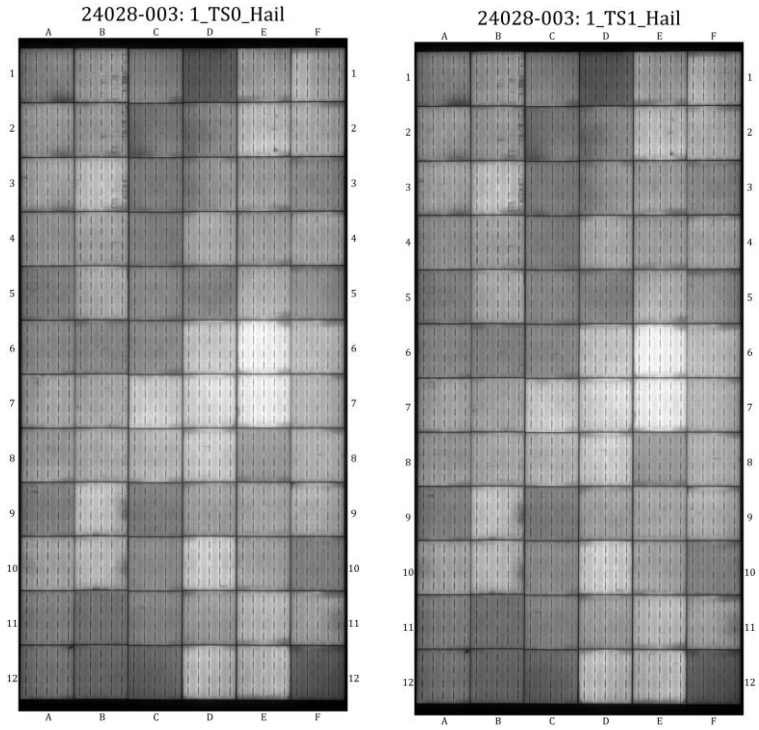
Electroluminescence (EL) Imaging – 1.0xIsc

No major visual defects were observed during the visual inspection of the tested modules.

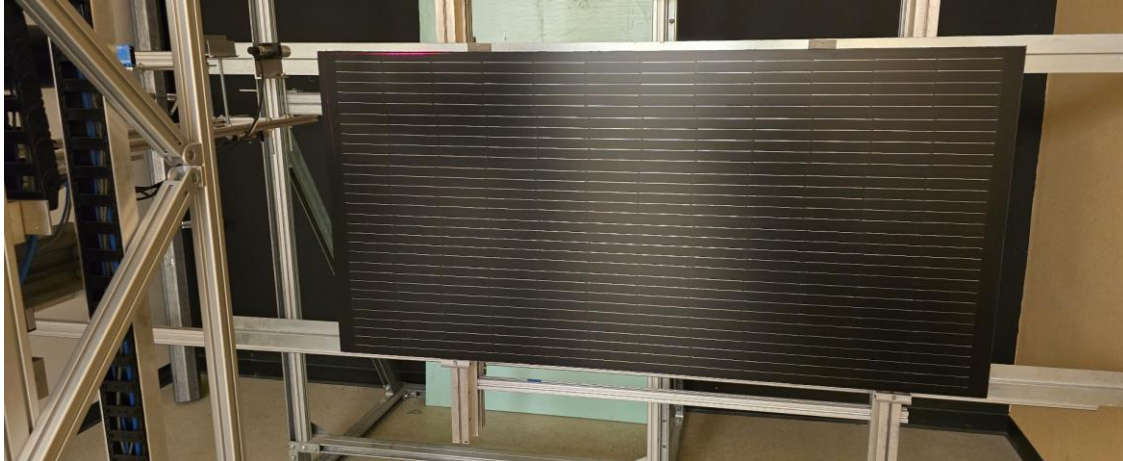
CFV Labs conducted hail testing using a pneumatic hail launcher (shown below).
